Flood and scour related failure incidents at railway assets between 1846 and 2013

April 2014
Project W13-4224

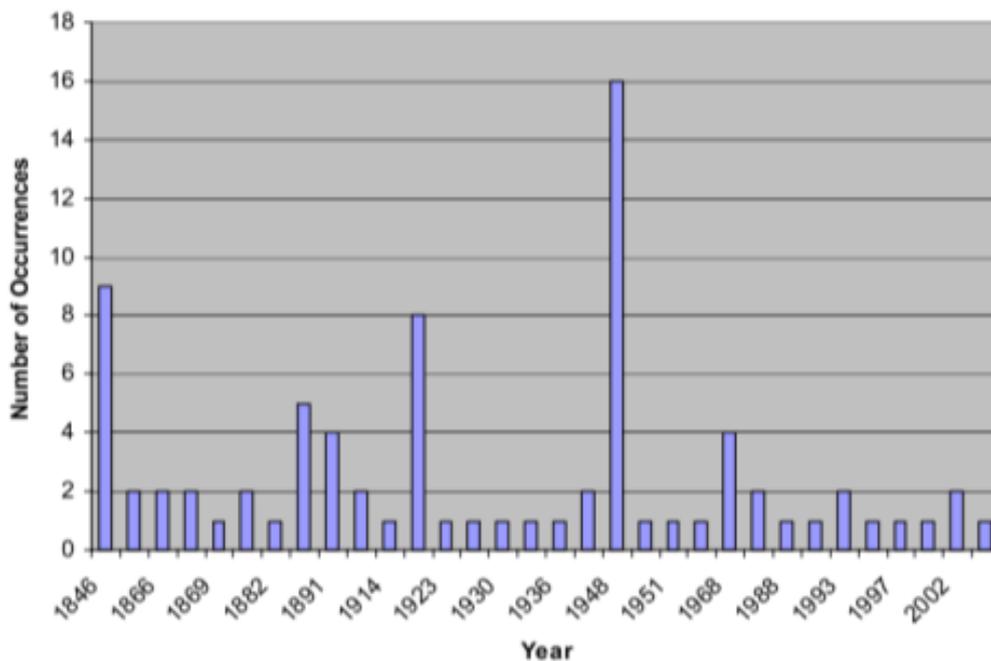
Figure 1: Timeline of bridge scour failures published by RSSB (2004)

Failure was defined as “complete or partial collapse of the structure sufficient to cause derailment or closure of the line” (RSSB, 2004). Figure 1 shows the timeline of incidents found in the study. No significant trend or periodicity was found for the incidents. It was found that failures could occur in any month of the year, but that there were more incidents in summer.

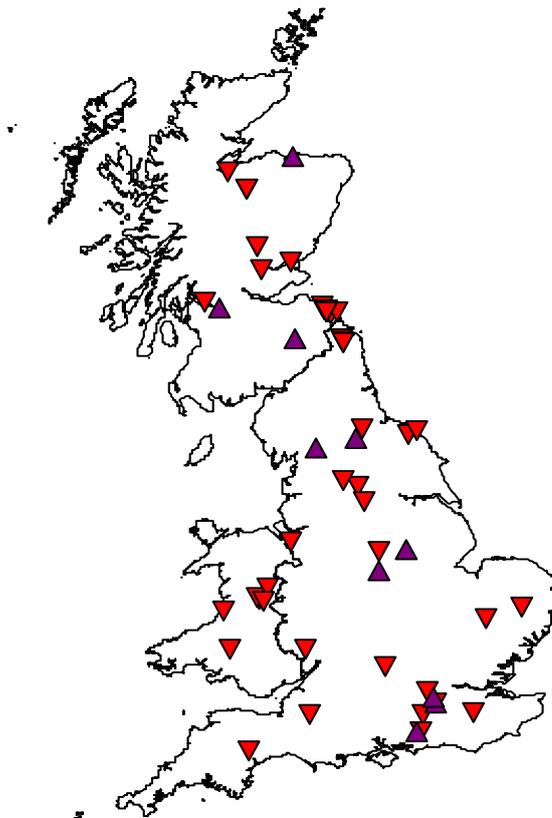
Figure 2: Geographical distribution of incidents (RSSB, 2004)

Figure 2 shows the geographical distribution of the failure incidents. It was found that many of the structure failures occurred in groups associated with a common flood event, and are therefore geographically close.

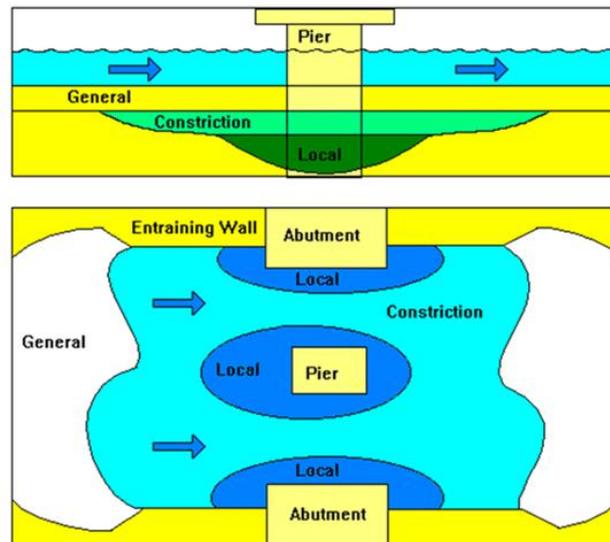
Figure 3: Components of total scour

There are three main scour mechanisms known as natural scour, contraction scour and local scour, which work additively to give total scour as shown in Figure 3.

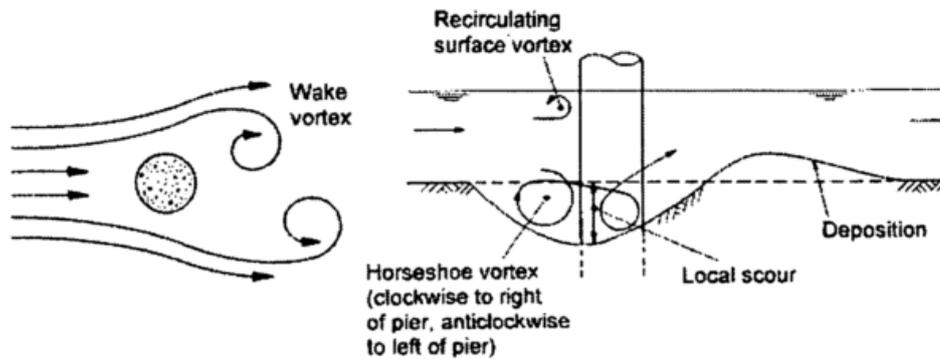
Figure 4: Local scour and turbulence at a circular pier (after May et al., 2002)

Formulae can be used to predict the depth of the scour hole caused by different types of structures. In the case of bridge abutments and piers the turbulent structure which occurs is known as the horseshoe vortex, shown in Figure 4. The vortices which are deflected to the downstream side of the pier increase flow velocities and cause scour of the river bed at this location, creating what is known as a 'scour hole'. Material from the scour hole is deposited downstream, further changing the river bed level. The flow structures are discarded periodically and move downstream, which can cause further erosion of the river bed downstream on either side of the pier (May et al., 2002).

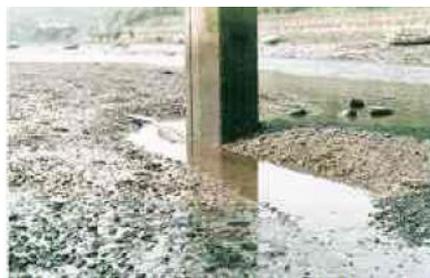
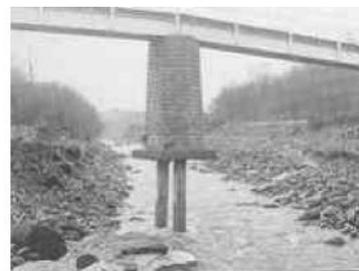
Figure 5: Structures showing a developing scour hole (left) and general scour (right), from Environment Agency (2004).

Bridge pier is 1.6m wide and 4m long. Direction of flow is from left to right

General or natural scour resulting in exposure of bridge foundations.

The three different scour mechanisms need to be considered when evaluating the scour conditions in a river. It is important to note that both long term, in the case of natural scour, and short term monitoring is required; the scour hole often re-fills after the flood event.

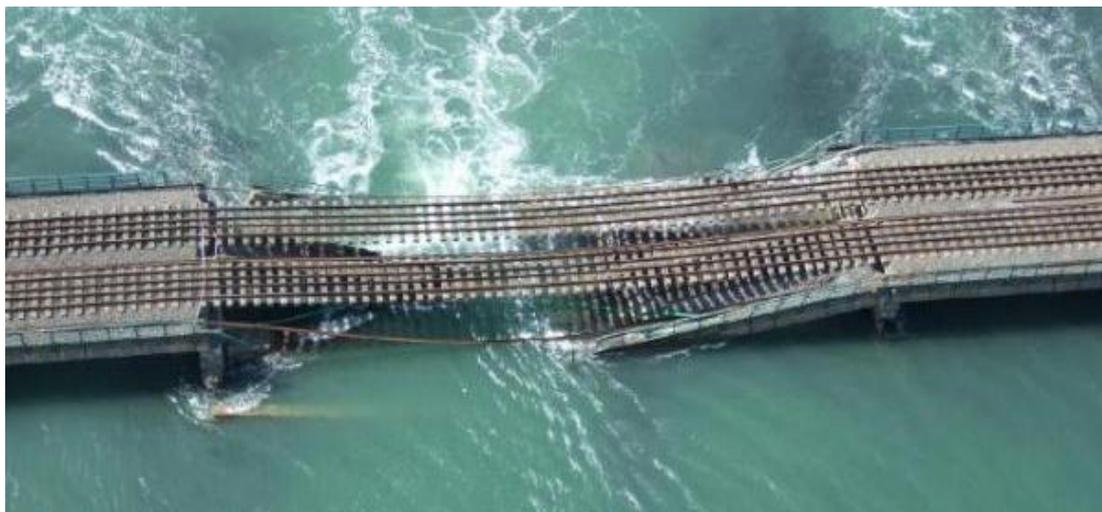
Figure 6: Malahide Viaduct Collapse (Railways Archive, 2010)

The collapse of the Malahide Viaduct in the Broadmeadow Estuary, Ireland (shown in Figure 6 and front cover) was a structural failure due to scour. A combination of natural scour and local scour led to the exposure of the pier foundations, which were undermined by hydraulic action resulting in the collapse of the pier when it was loaded by two trains in August 2009 (RAIU, 2010).

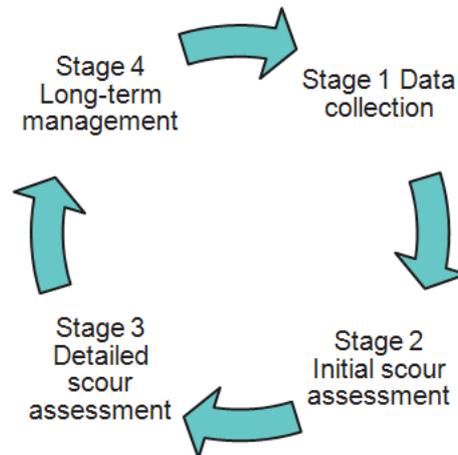
Figure 7. Network Rail scour assessment procedure

Network Rail follows a four step process in the management of scour as shown in Figure 7. A risk based approach is used to assign priority ratings to structures depending on the level of assessed risk from scour. This procedure was developed following the 1987 Glanrhyd disaster

and was known as *Handbook 47* (British Railways Board, 1989), this was revised in 1992 and is now generally known as *EX2502* (Bettess, 1993).

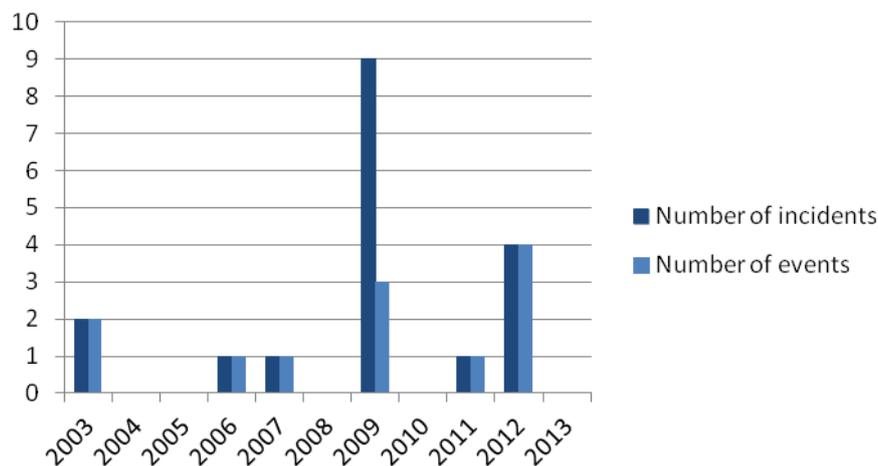
Figure 8: Counts of number of failure incidents by year, and the number of hydro-meteorological events associated with one or more failures.

Figure 8 shows a time series of the failures during the period studied. The difference between the number of incidents and number of events is accounted for by the seven Cumbrian bridge failures that occurred during the same event in 2009 (although this was not the only flood event related to a failure incident in 2009).

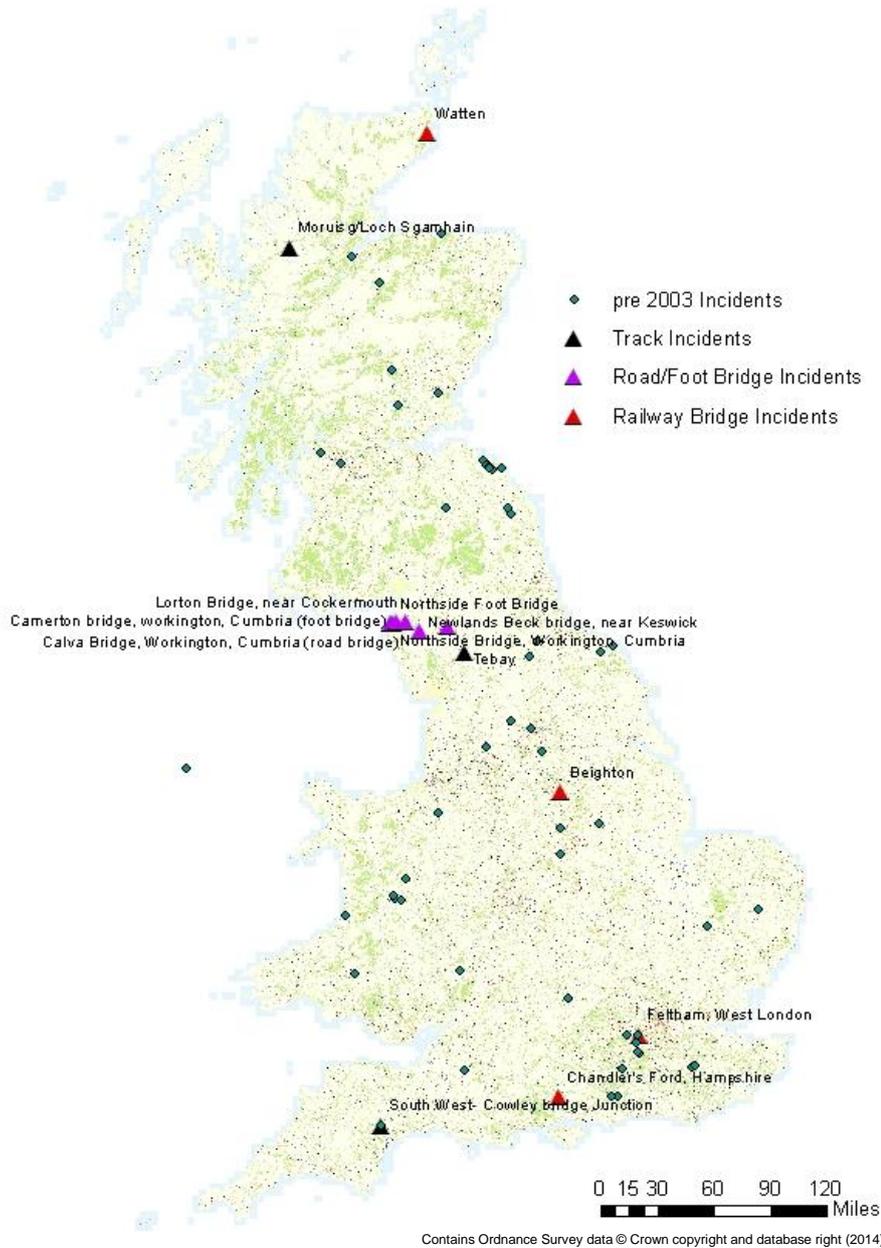
Figure 9: Incident map

Figure 9 shows the locations of the scour failure incidents found between 2003 and 2013. It can be seen that the incidents are geographically spread out, except for the road/footbridge failures in Cumbria which occurred during the same event. This is similar to the findings of report T112. The cluster of incidents in Cumbria is not a repeat of any of the clusters found in the previous study.

The Incident in Feltham in 2009 adds to the events found in the previous study clustered around London. The only repeated event is Cowley Bridge Junction in the South West, which is known to flood on a regular basis.

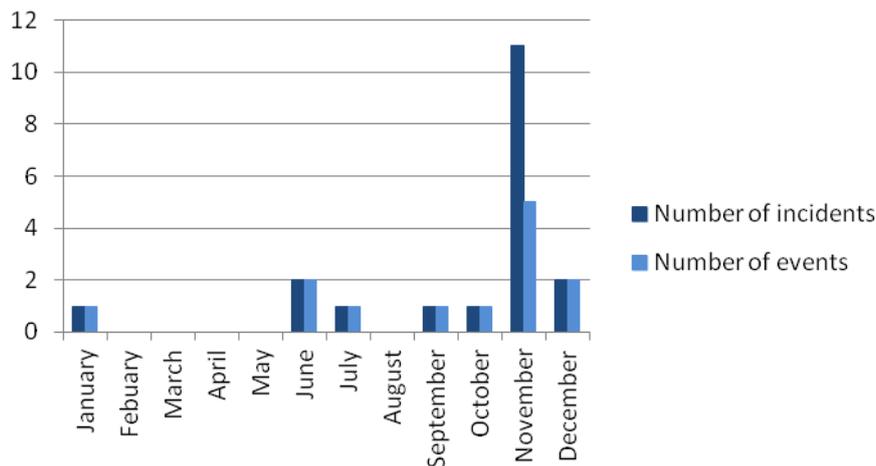
Figure 10: Count of number of failures by month

Figure 10 shows that there is a skew of failure events towards the winter months. This is as expected as this is known to be the main flood season. However, it is in contrast to the previous RSSB (2004) study of the longer historical record, which found more scour related failures to occur in the summer months.
