# Emergence of an ephemeral chalk stream at Assendon, Oxfordshire, in 2014

**November 2016**

**W15-1389**

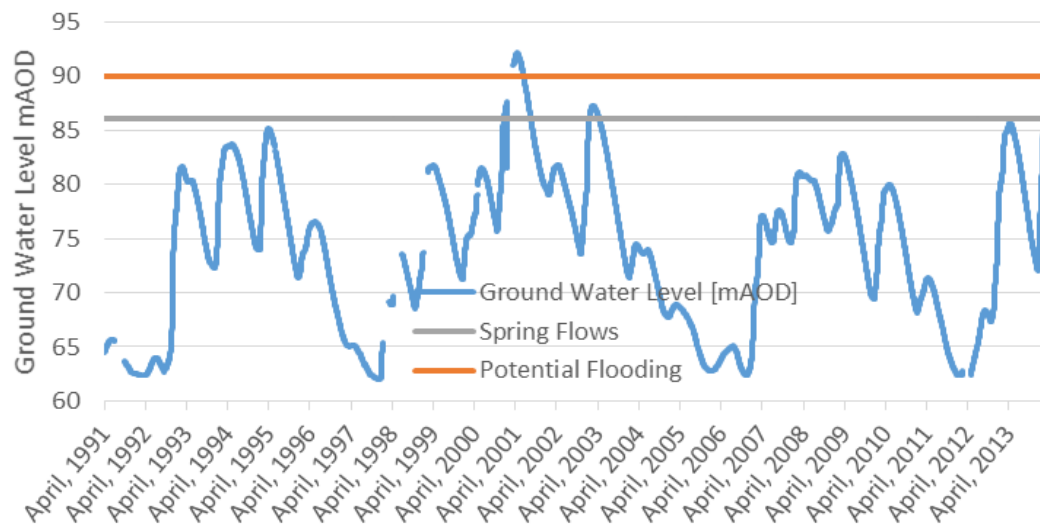
**Figure 2:** Stonor Park borehole ground water levels 1991 - 2013

These threshold levels help to link hydrological conditions and extent of the emergence of Assendon Stream to the ground water levels recorded by the Stonor Park borehole (Figure 2).

The groundwater levels in the Berkshire Downs Chalk above Henley-on-Thames are monitored by several boreholes. Stonor Park, drilled to a depth of 147.5 meters into the Lewes Nodular Chalk (an unconfined aquifer), has the longest uninterrupted data record (weekly data records since 1963, and daily records since 1991) and is used by the Environment Agency for quarterly hydrometric reporting.

The groundwater displays a regular annual sinusoidal pattern and captures the aquifer's full range of fluctuation. The aquifer block monitored at Stonor is one of the larger chalk blocks without surface drainage, and as a result of this its response to individual recharge events is damped compared with other boreholes in the area.

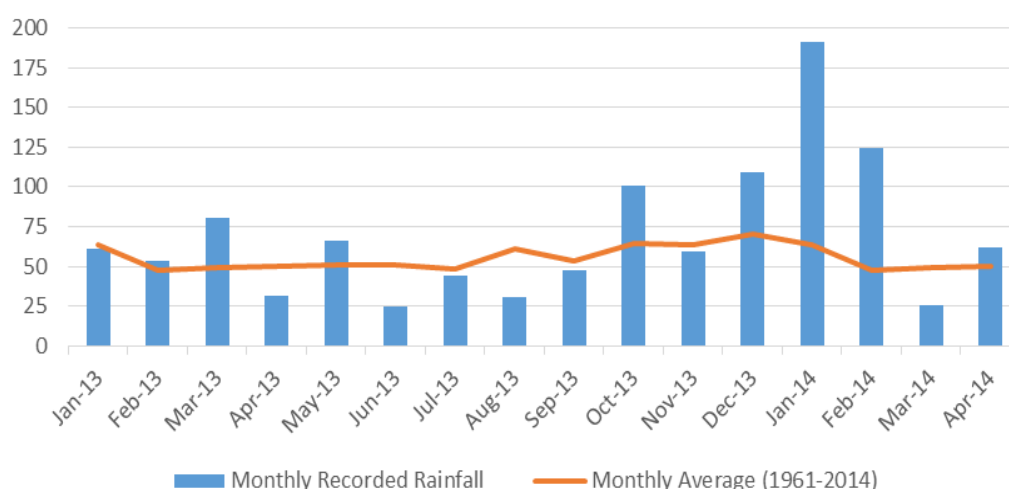
**Figure 3:** Rainfall totals (mm) recorded at Hambleden Lock (January 2013 to April 2014)

**Figure 3** compares the monthly rainfall totals recorded at the nearby Hambleden Lock rain gauge against the long term monthly average. The winter rainfall figures reflect the national trend of an extremely wet winter with January and February receiving over double their recorded long term average rainfall.

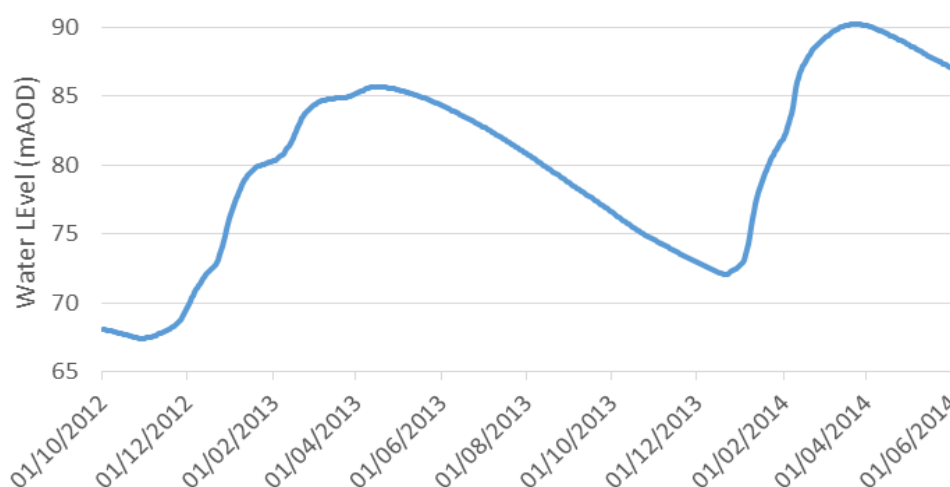
**Figure 4:** Stonor Park Borehole water levels (October 2012 to June 2014)

Following the exceptionally wet start to the year ground water levels at Stonor Park began to rise rapidly to high levels (**Figure 4**). This suggested a strong possibility that the Assendon Spring may flow during early 2014.

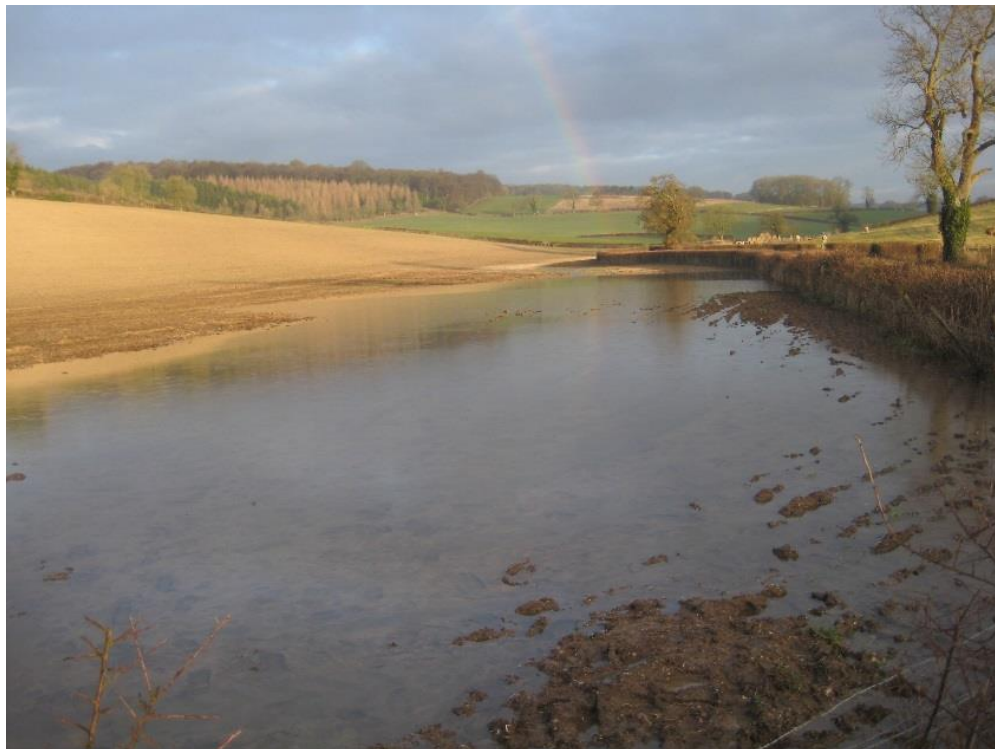
**Figure 6:** The Assendon Spring Source rising on 19 February 2014

The photographs in [Figure 6](#) and [Figure 7](#) show the progress of the event at key locations and represent a small selection of the complete photographic record of this event.

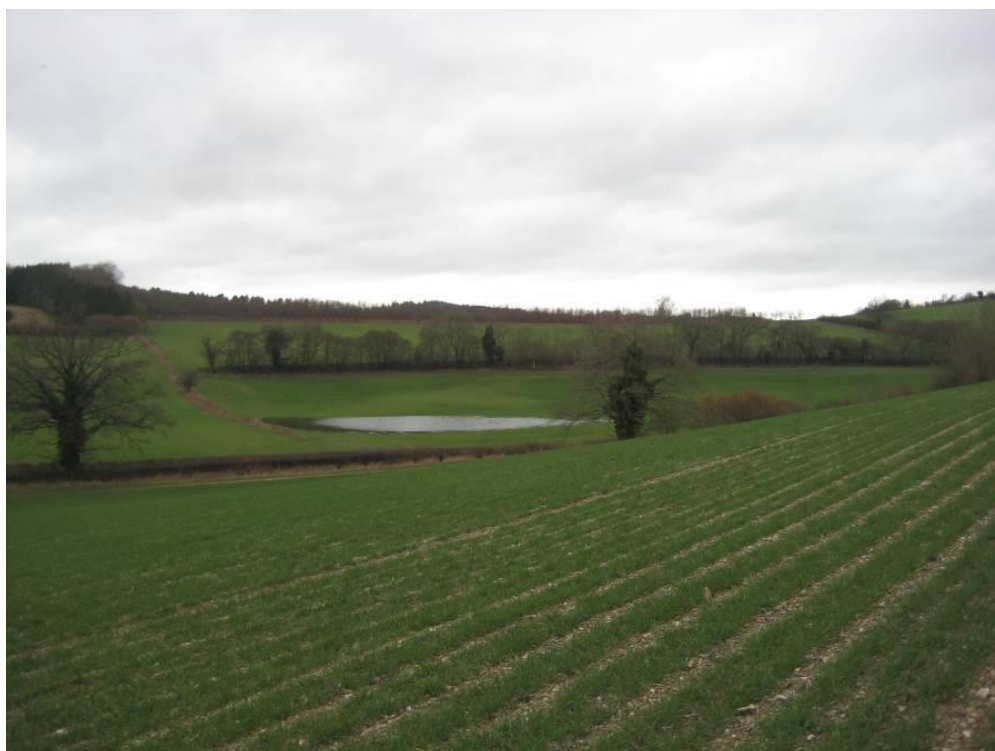
**Figure 7:** The Assendon Spring ground water rising on 3 March 2014

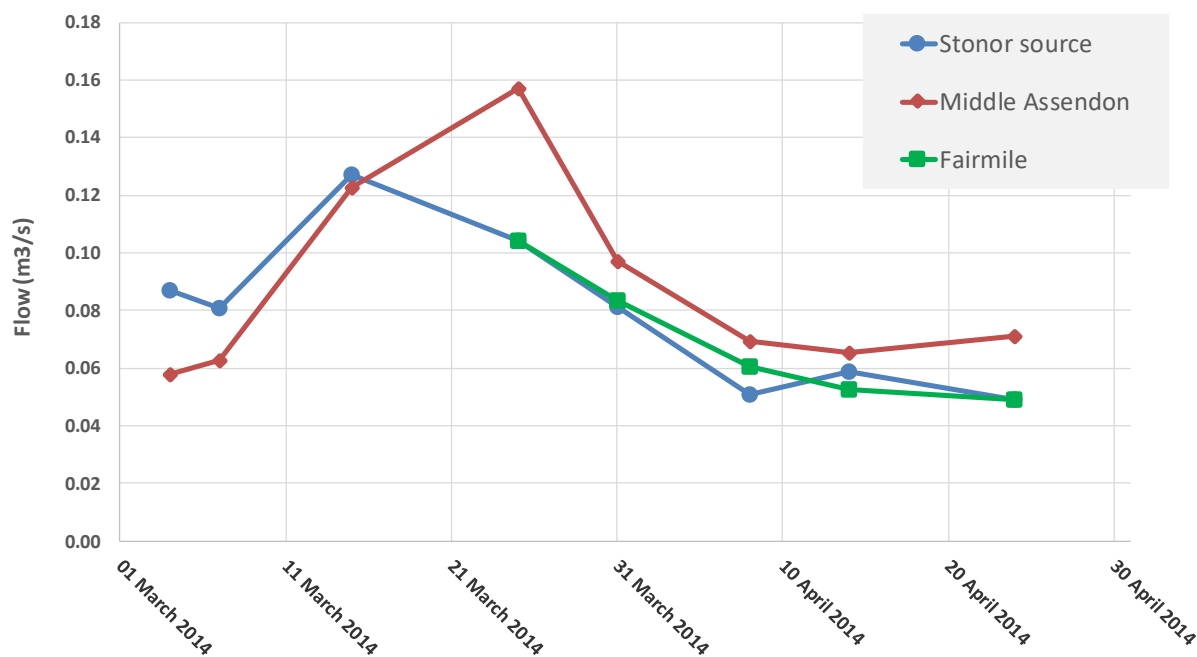
**Figure 8:** Assendon Stream flow gauging measurements

The peak flows recorded between 15 and 31 March 2014 appear to coincide with the peak ground water levels of over 90 metres AOD.

Stream flow has been estimated by velocity-area calculation. The resources available for field work allowed for depth and velocity measurement, but not continuous water level monitoring. On each field visit, three manual “spot” velocity and depth measurements were made at approximately the same locations within the channel at each cross section. Flow velocity was read out twice during each measurement, with the average of the two readings being used in the flow calculations.

In the absence of water level monitoring, the spot gauge flow depths have been combined with the cross section survey data to reconstruct a water level for each velocity/depth measurement. The average of three such water level estimates has been used in order to compute the cross sectional flow area for each of the observations.

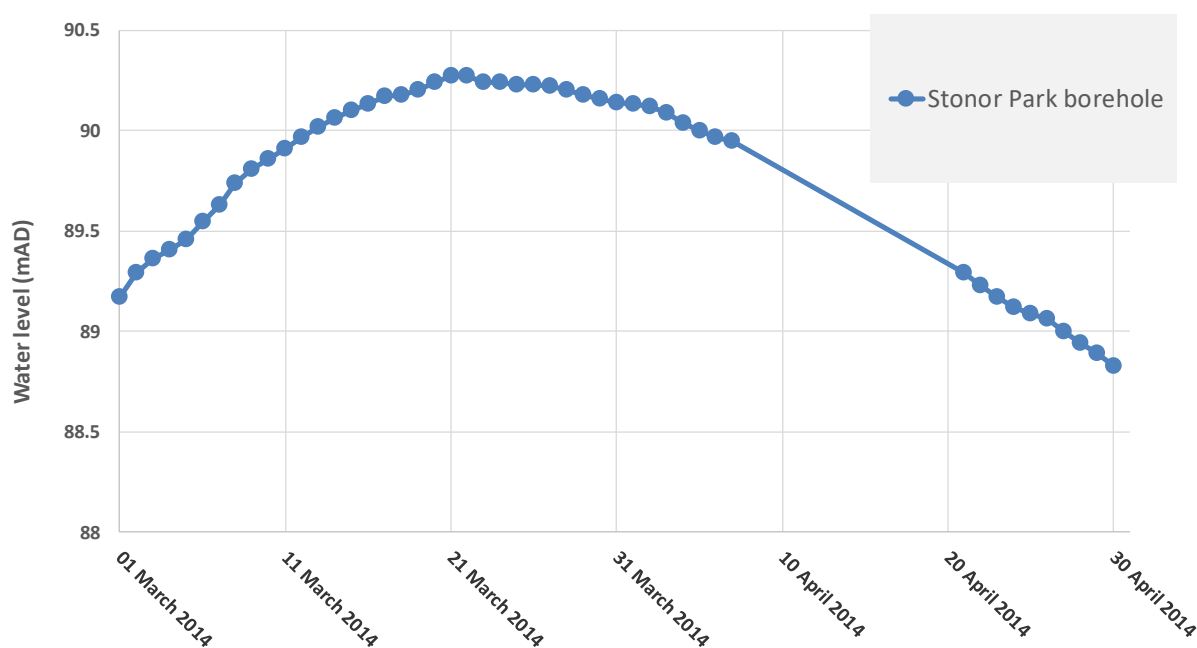
**Figure 9:** Stonor Park borehole levels for the period during which flows in Assendon Stream were measured

Monitoring of the spring ceased once it became clear that the groundwater levels were receding and that recharge to levels seen in 2001 was unlikely given the below average rainfall during March.

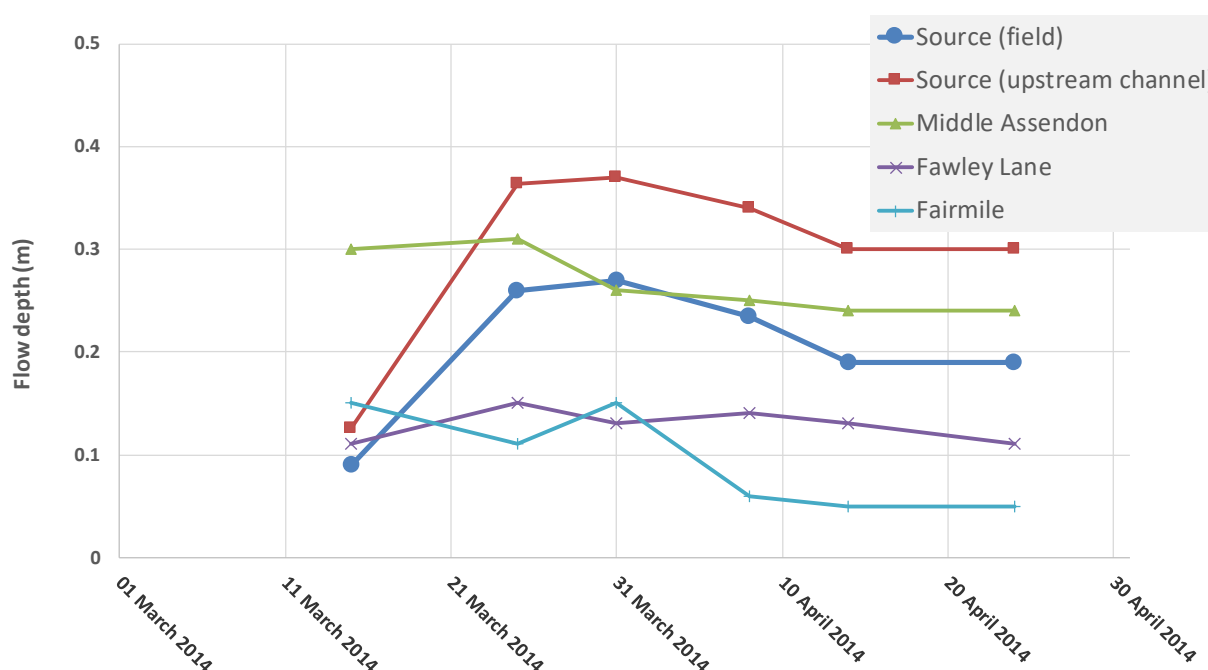
**Figure 10:** Assendon Stream flow depths measured at culverts

The results of the culvert depth monitoring are shown below in Figure 10. The results mirror those of the flow monitoring in terms of the rise and fall in stream levels.

In addition to flow monitoring, the flow depths at fixed structures were also recorded during the event in order to track relative water levels over time. Channel depths at the downstream end of several culverts were measured with the culvert soffit levels providing fixed reference points. The locations of the gauging points are described in Table 4.
